Manhole Inspection Summary

Manhole # S21K__048MH

Location Address: **1933 s payson-goldsmith alley**

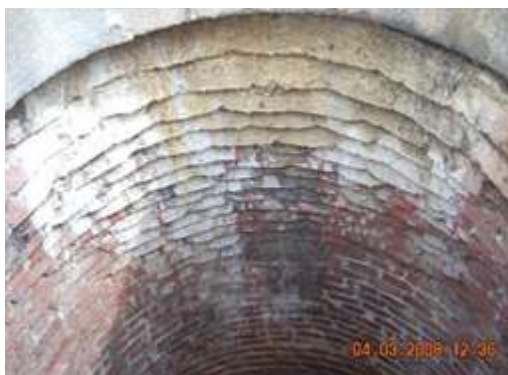
Defect 5

Infiltration: ☐ None ☒ **Joint** ☐ Cracks ☐ Mortar ☐ Roots ☐ Wall

infiltration @ chimney joint

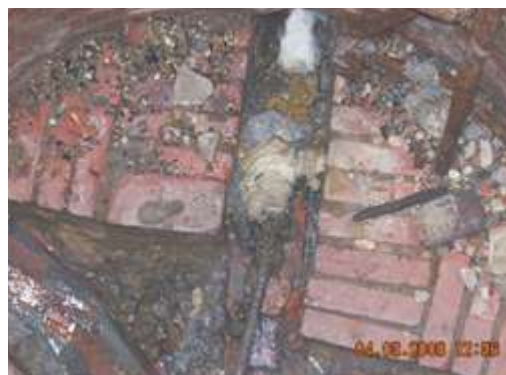
Defect 4

Condition: ☐ Sound ☐ Cracked ☐ Root Intrusion ☐ Deteriorated ☐ Leaks ☒ **Debris**

debris in service channel @ 6 o'clock,
bench debris

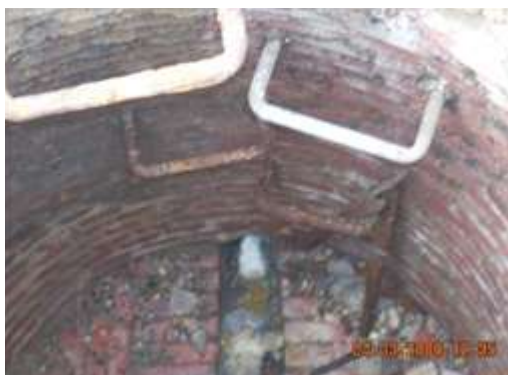
Defect 3

Steps Count: **4** Missing: **0** ☒ **Corroded**

corroded steps

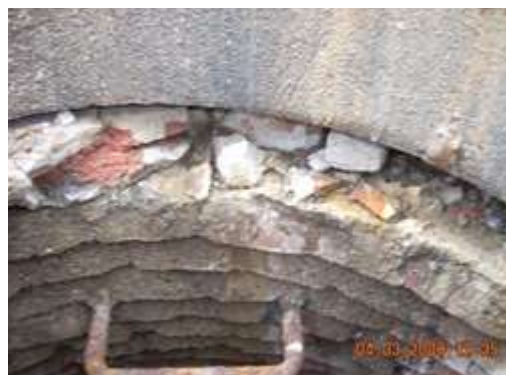
Defect 2

Condition: ☐ Sound ☐ Cracked ☐ Root Intrusion ☐ Loose Brick ☒ **Deteriorated**

deteriorated chimney

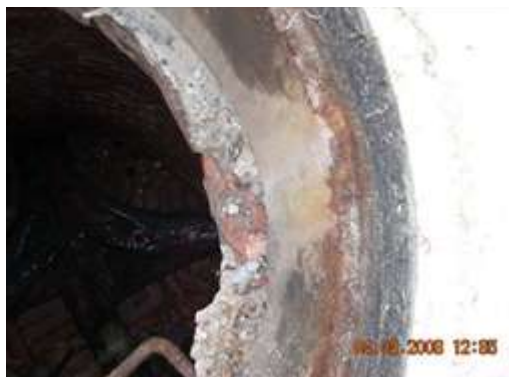
Defect 1

Frame Offset: **2** (in.) Condition: ☒ Sound ☐ Cracked ☐ Leaks

frame offset

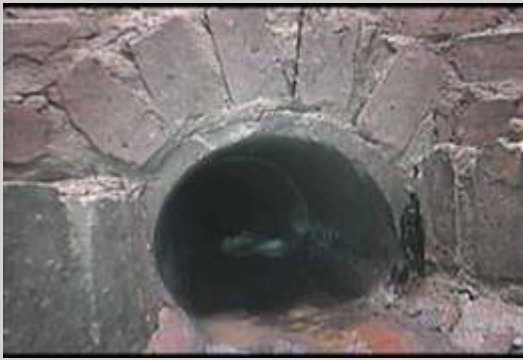
12 O'Clock Outflow

Pipe Height: **8.4** (in.) Rod and Bar (Angled)
Pipe Material: **Clay** ☐ Pipe Lined
Invert Depth: **8.09** (ft.) Flow Characteristics: **Slow**
Deposits: ☒ None ☐ Mud ☐ ~~Gravy~~ ☐ Debris ☐ Grease
Silt Depth: **0** (in.) Deposits Extent:
Infiltration: **None** Pipe Seal Cond: **Cracked**

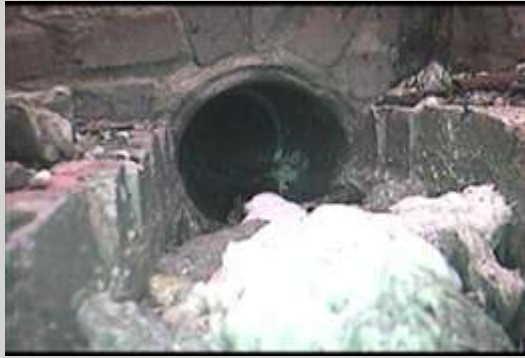
6 O'Clock Inflow

Deposits: ☐ None ☐ Mud ☒ Sludge ☒ Debris ☐ Grease

Silt Depth: **3** (in.) Deposits Extent: **Medium**

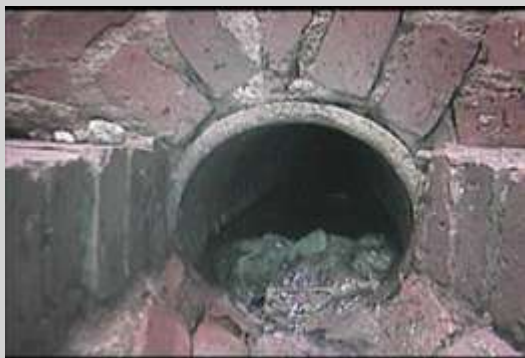
9 O'Clock Inflow

Deposits: ☐ None ☒ Mud ☒ Sludge ☐ Debris ☐ Grease

Silt Depth: **3** (in.) Deposits Extent: **Medium**
